**Fatality #10 - April 28, 2005**  
**Machinery - MT - Platinum Group Ore**  
**Stillwater Mining Company - Stillwater Mine**

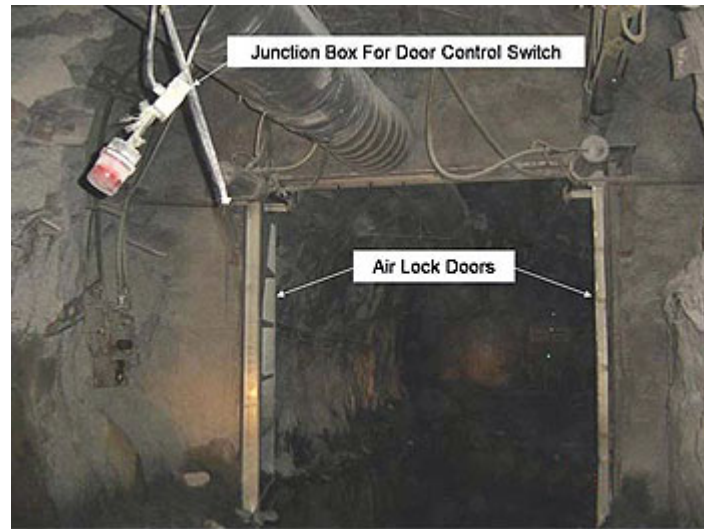
**METAL/NONMETAL MINE FATALITY** - On April 28, 2005, a 52-year-old electrician leadman, with 30 years mining experience, was fatally injured at an underground platinum operation. The victim was last known to be working on a door control switch located approximately 15 feet from a set of air lock doors. A co-worker, returning to the area, found him caught between the closed doors.

- Conduct a Risk Assessment and communicate before beginning a task, to evaluate the work procedures, identify all possible hazards, and ensure steps are taken to safely perform the task. Establish procedures to safely complete repair tasks.
- When working near air lock doors, block them and bleed off any stored energy to prevent hazardous movement.
- Ensure that miners are not positioned in areas where they are exposed to hazards resulting from a sudden release of energy.
- Before working on equipment, disconnect power from the circuit, lock out, and tag out the circuit.
